*Stage 1 Report: Par Sands*

# Cornwall Beach & Dune Management Plans

Prepared for  
**Cornwall Council**

9 July 2015

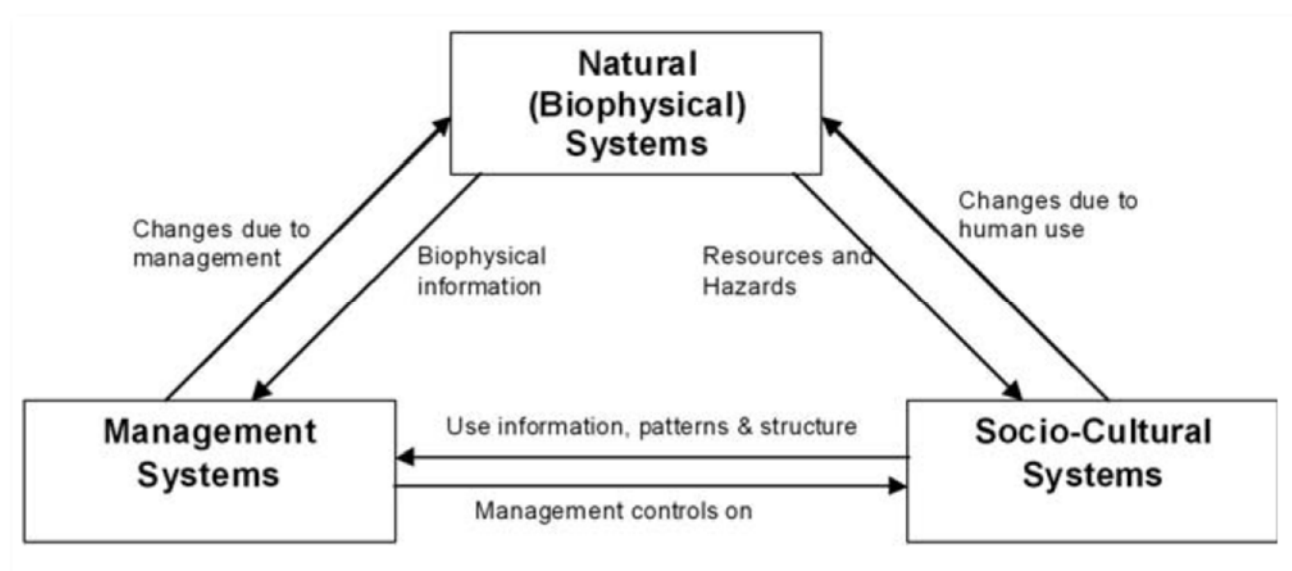
Figure 1.1 The interaction of beach systems that compose the 'beach environment' and which must be considered together to provide a holistic approach to beach management (after James, 2000 in Frampton, A.P.R. (2010). "A review of amenity beach management". *Journal of Coastal research*, 26(6), 1112-1122, November 2010).

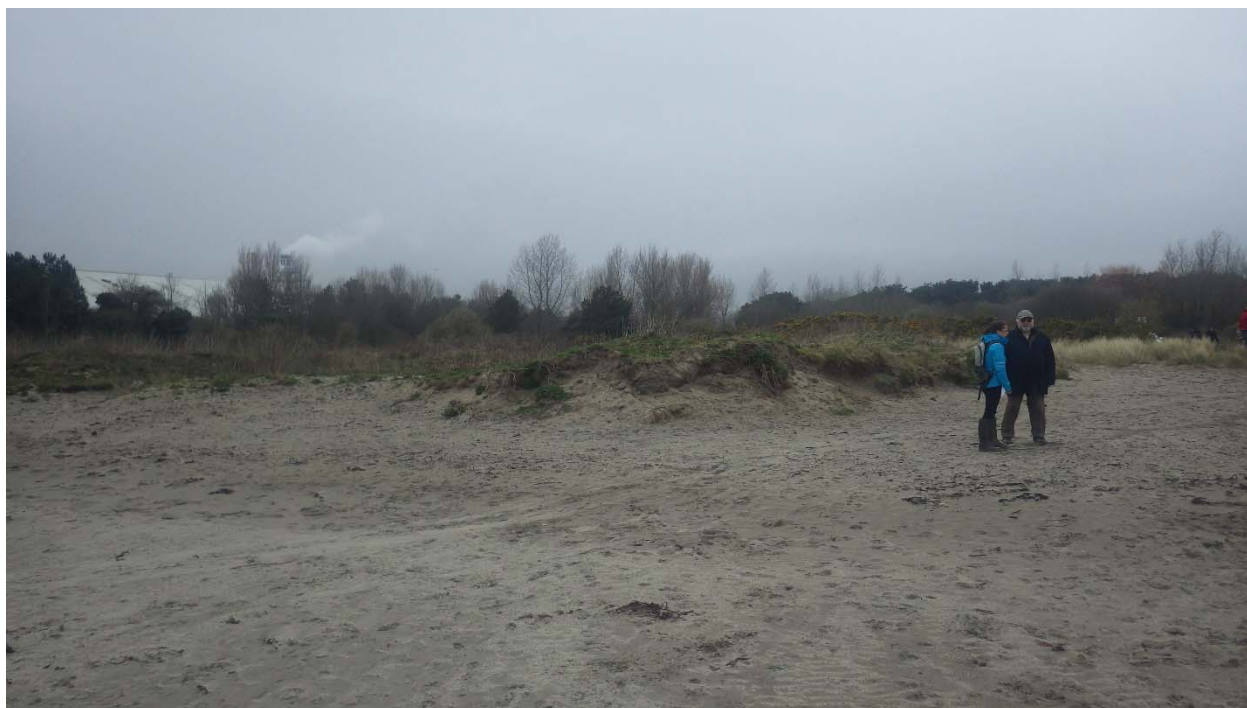
*Photograph 2.1 Western end of beach.*

At the western end of the beach there is a small section of landfill, which is comprised of seaweed and litter picked up from the strandline (see Photograph 2.1). Some of this fill was washed away during the 2014 storms. The process of beach clearing is no longer undertaken, and seaweed is left to build-up along the strandline in the summer for environmental reasons.

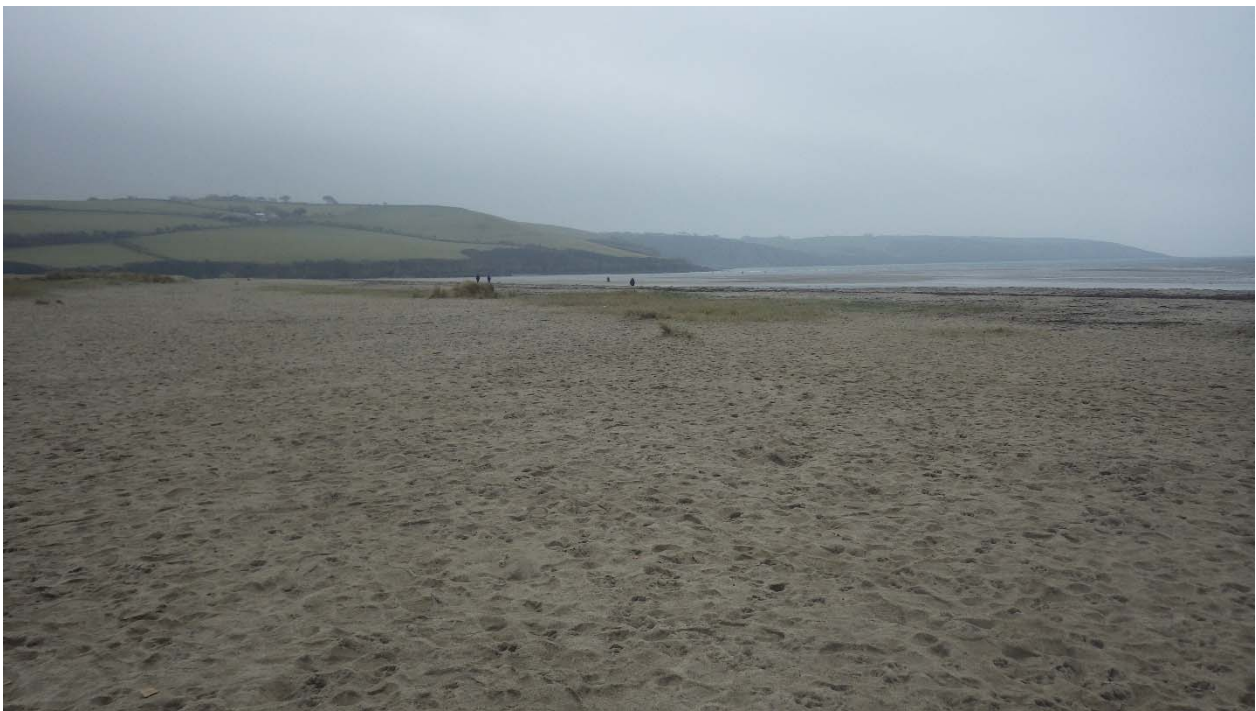
*Photograph 2.2 Evidence of dune growth.*

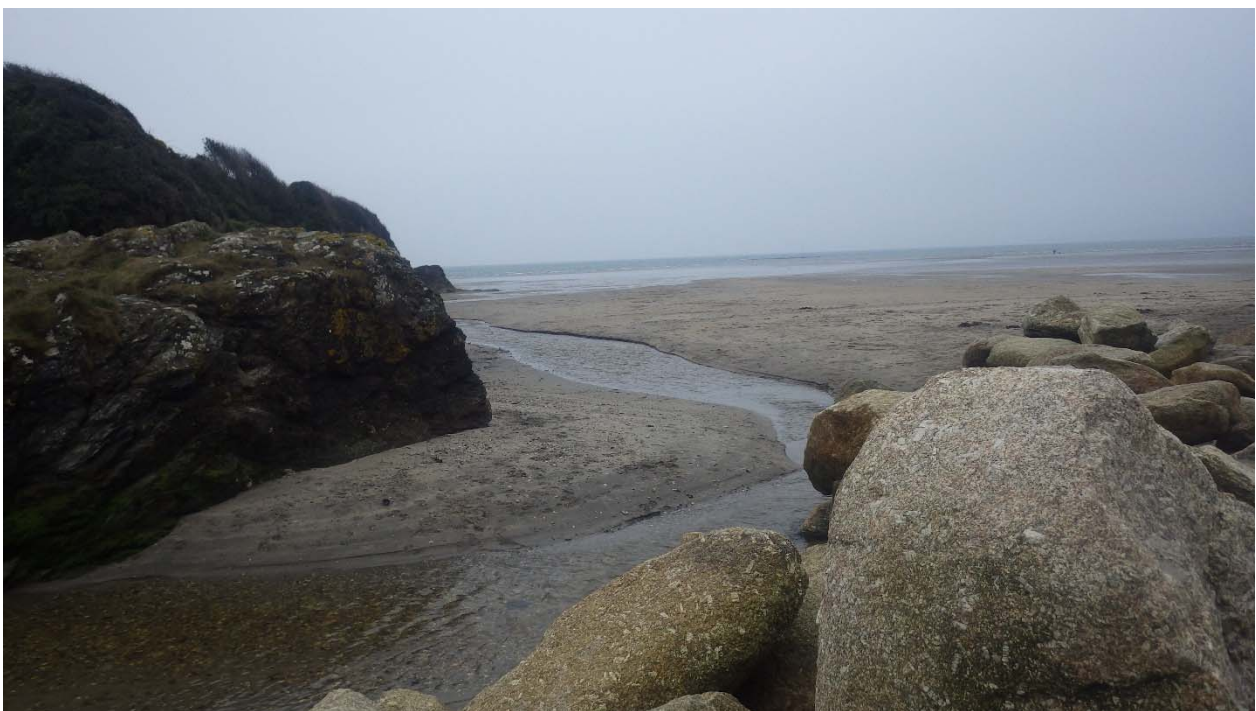
*Photograph 2.3 River bank stabilisation placed in 1970s (view seawards)*

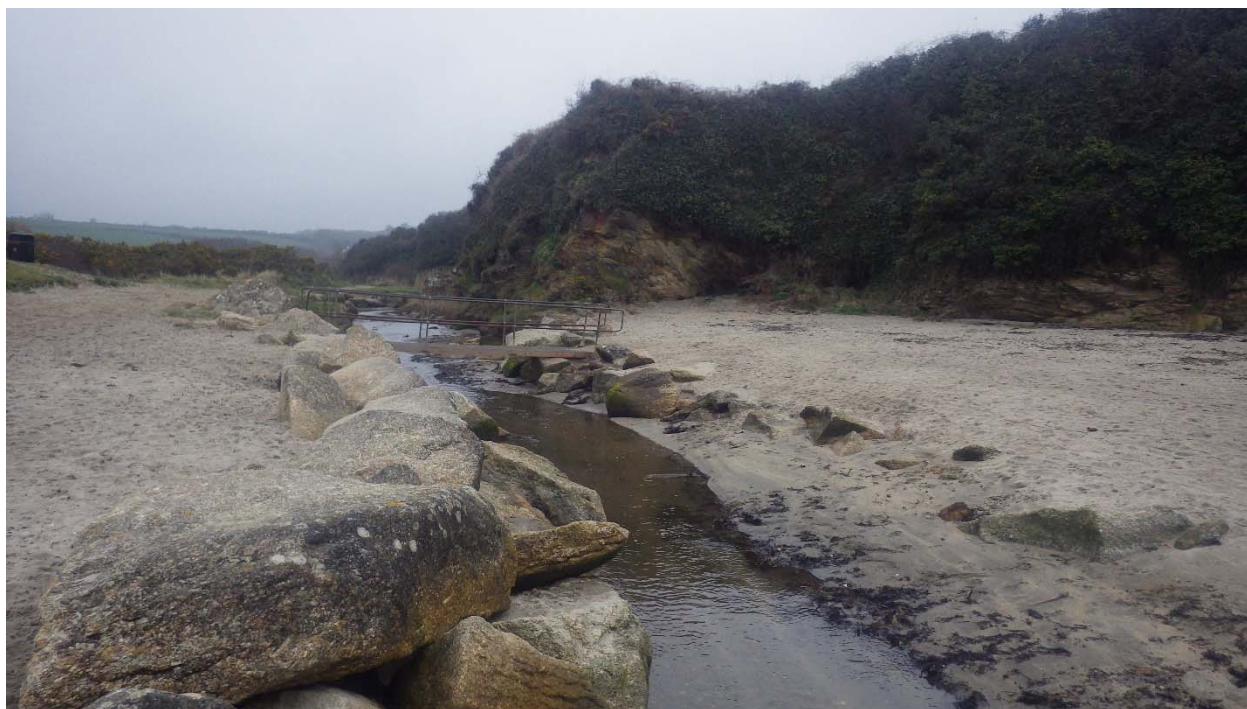
*Photograph 2.4 River bank stabilisation placed in 1970s (view landwards)*

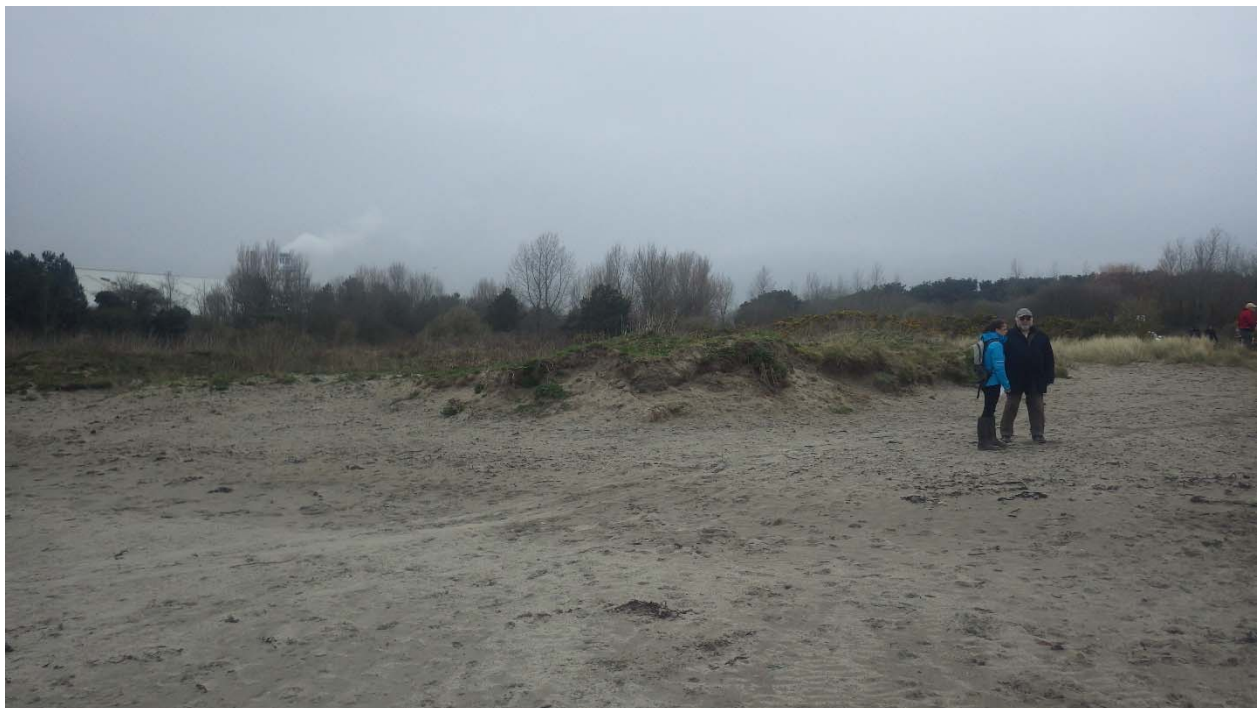
Figure 4.2 Landfill, comprised of seaweed and litter collected from the strandline at Par Sands (taken during site visit 12<sup>th</sup> March 2015, looking west).

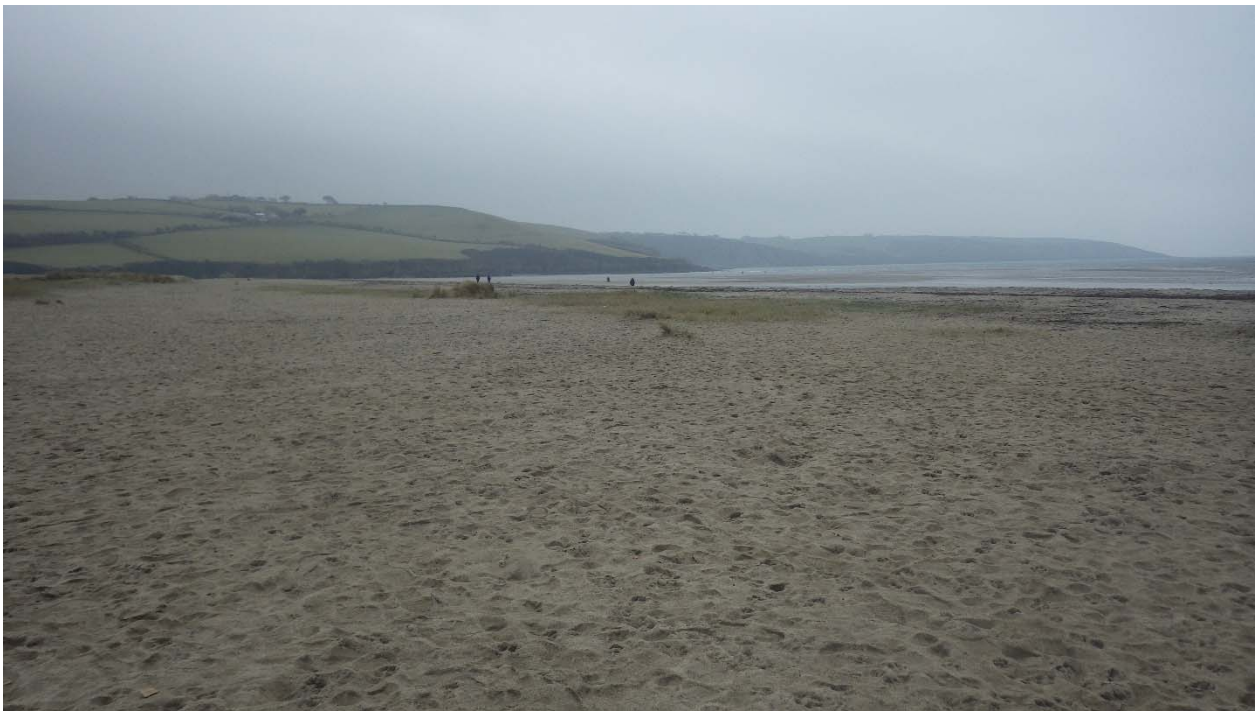
*Figure 4.3 Dune accretion and embryo dune growth at Par Sands (taken during site visit 12<sup>th</sup> March 2015, looking south-east).*

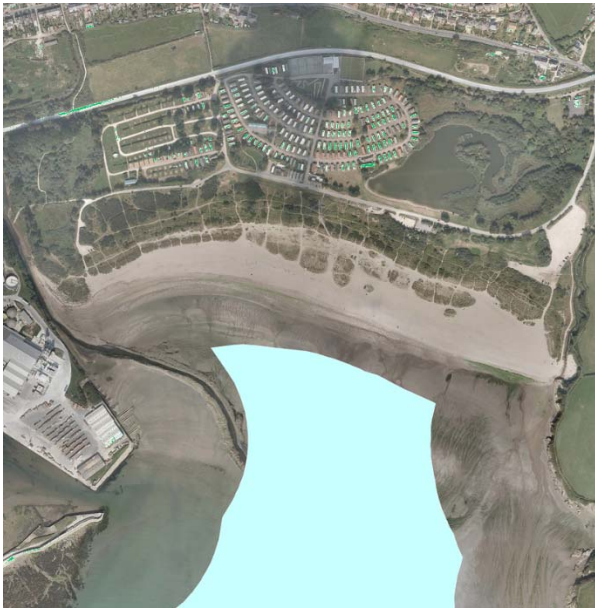
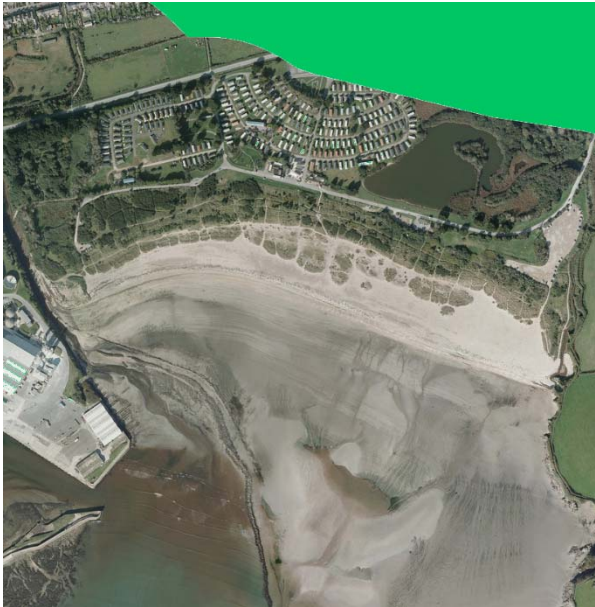
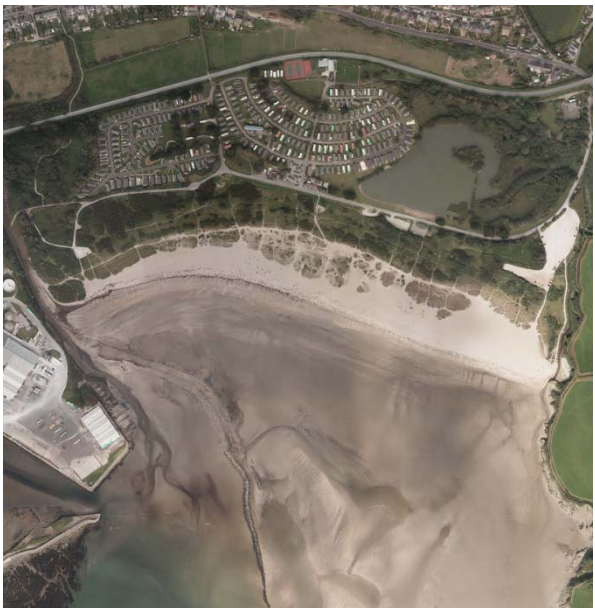
Figure 4.4 Historical photographs of Par Sands (source: Plymouth Coastal Observatory).

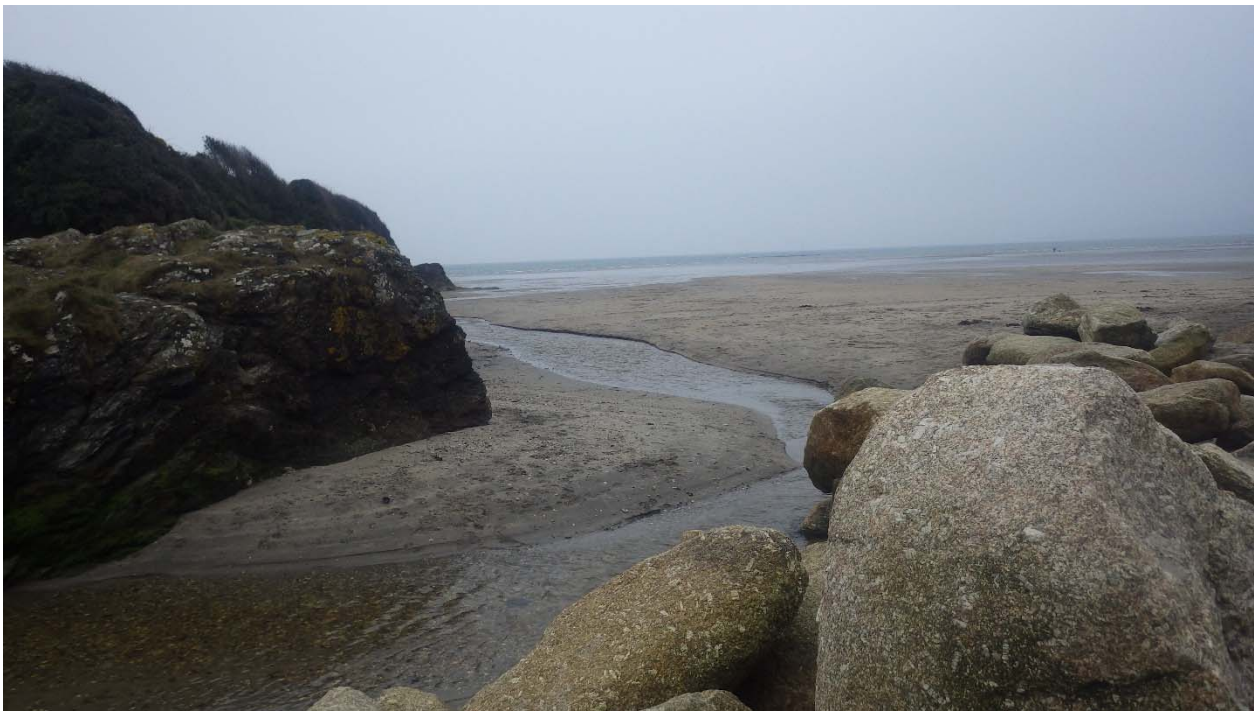
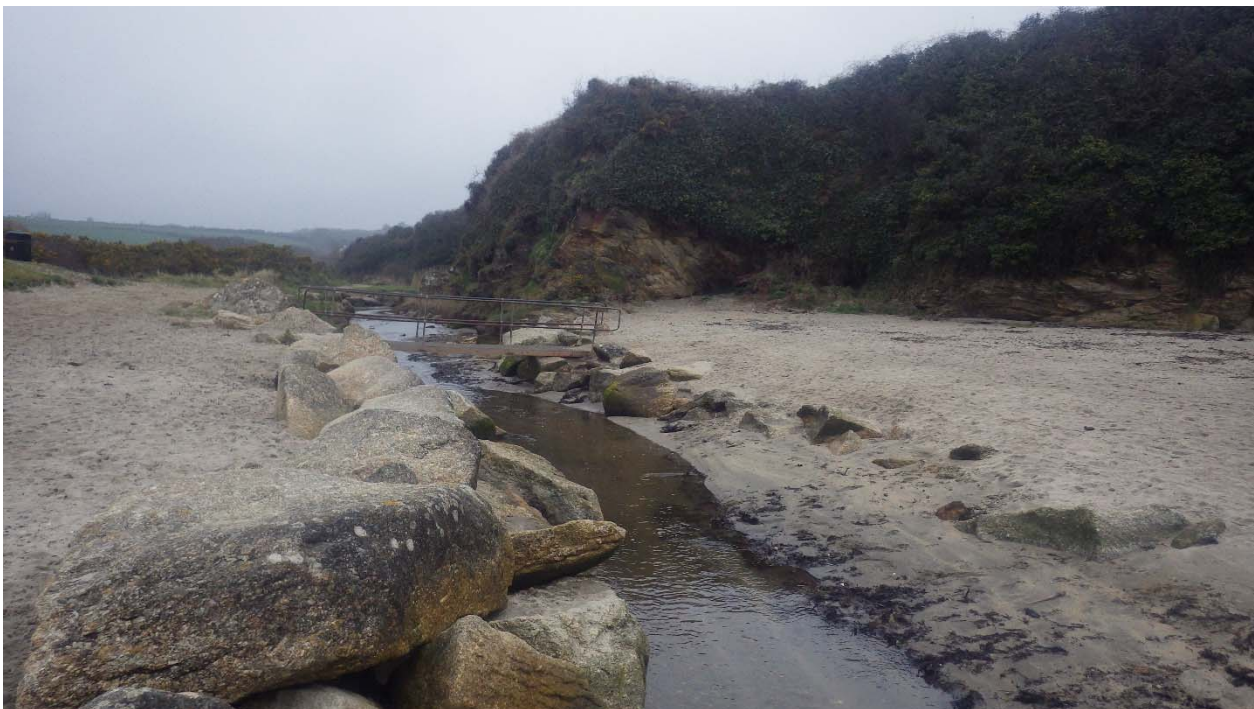
*Figure 4.5 Rock boulders in Polmear stream, used to stabilise the channel (taken during site visit 12<sup>th</sup> March 2015, above – looking south and below – looking north).*

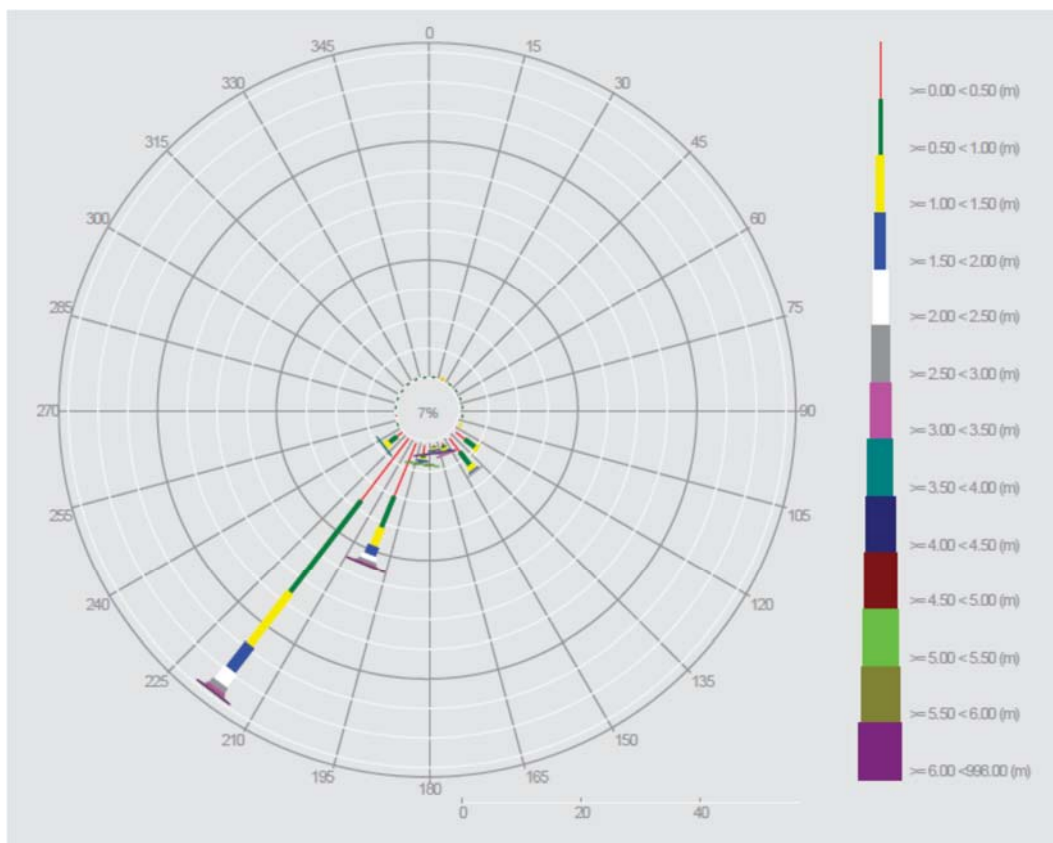
Figure 4.7 Offshore wave height recorded by the Looe Bay Directional Waverider Buoy between 22nd June 2009 and 30<sup>th</sup> June 2014 (PCO, 2014a).

December 2006 and 30th June 2014. A plot of wave height in Figure 4.7 4.7 shows that the predominant wave direction in this area is from the west. The data set also indicates significant wave heights frequently exceed 5m during the winter months and that wave periods of 15 seconds and higher (i.e. powerful well waves generated by storms offshore) are not uncommon (Royal Haskoning, 2011b).

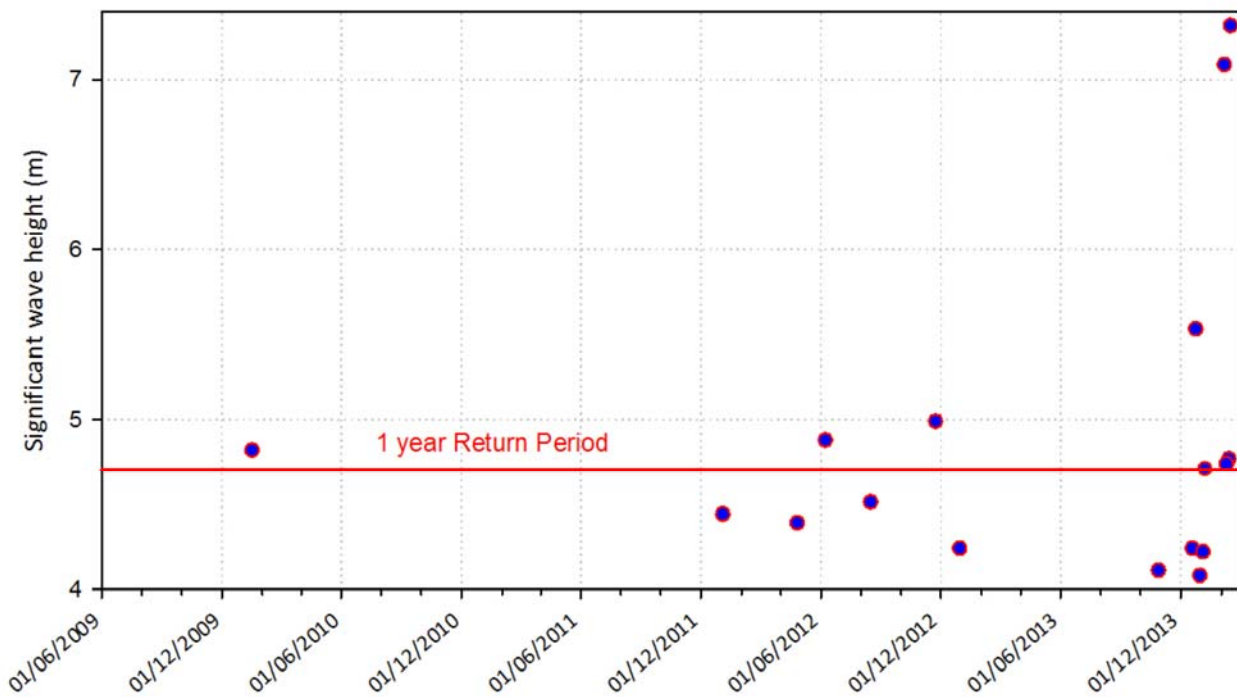
Figure 4.8 Storm calendar for Looe (source: PCO, 2014b).

For their reporting, PCO produce a storm calendar. The calendar includes a graph, where each dot represents a storm (i.e. where the  $H_s$  exceeds the storm threshold) and shows the  $H_s$  for that particular storm. PCO plot the significant wave height for the 1 year return period for that particular buoy on the graph (calculated in the same way as significant wave height for the 0.25 year return period) as a red line. Where storms plot above the red line they are considered to be more severe/extreme and are listed in a separate table. The storm calendar and table for the Perranporth Directional Waverider Buoy are presented in Figure 4.8 and Table 4.1 respectively.

The storm calendar shows that nine severe/extreme storms have exceeded the 1 year Return Period since 2009; six of those storms (67 %) occurred between October 2013 and February 2014. The impact of these storms on beach change is described in Section 4.3.

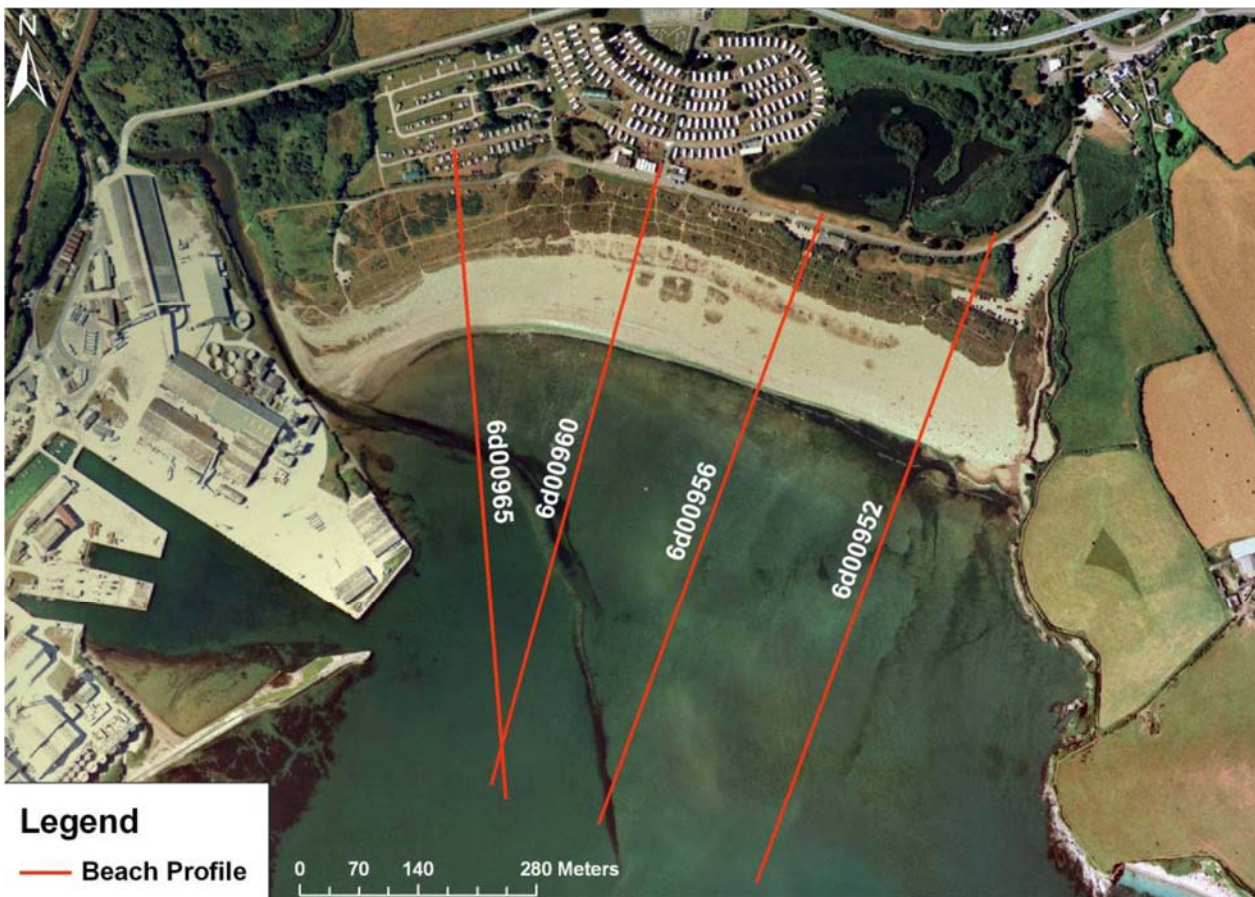
Figure 4.10 Diagram showing position of SWRCMP beach profiles at Par Sands.

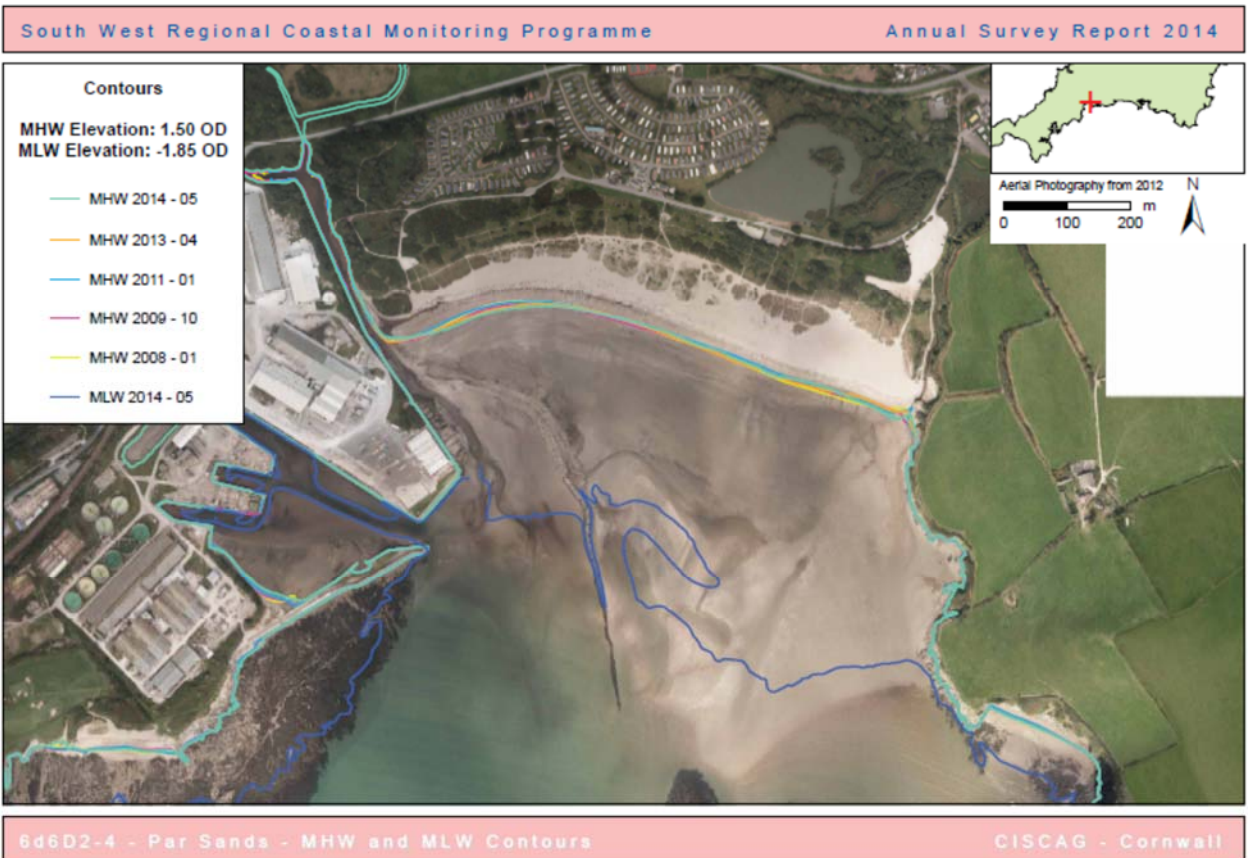
Figure 4.13 MHW contour change at Par Sands (source: PCO, 2014a).

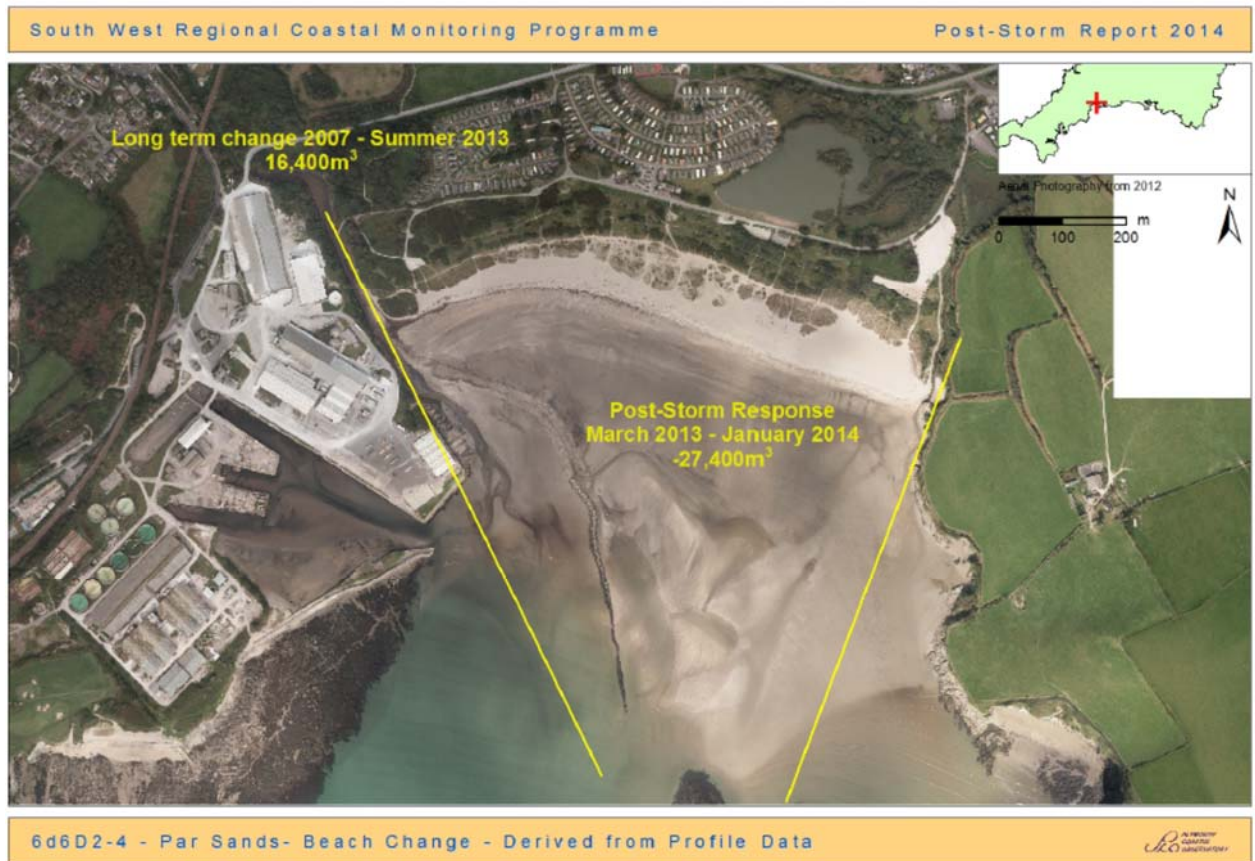
Figure 414 Volume change at Par Sands (PCO, 2014b).
